2. Existing Conditions and Recommended Improvements

TELECOMMUNICATIONS INFRASTRUCTURE

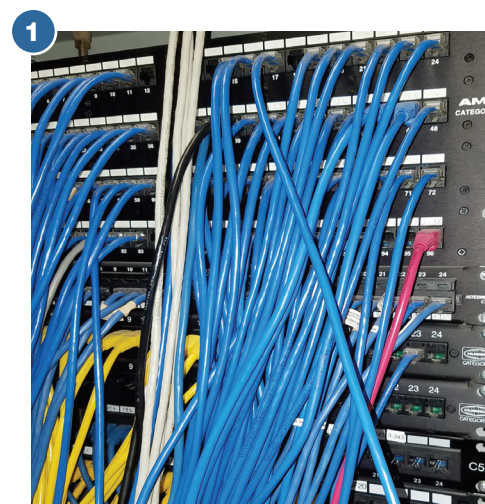
1. ES and MS non-compliant horizontal cable management.
2. Typical ES and MS cabling with non-compliant labeling.
3. Improperly supported horizontal cable in the High School.
4. Ladder racking correctly installed and deployed in the MTR - Server Room 154.

1. Remove abandoned cabling and equipment.
2. Implement consistent cable labeling standards.
3. Install cable tray down all corridors.
4. Install additional conduit. Firestop all conduits.
5. Ground cable tray and conduit.
