- Technology Condition Survey Report
- Telecommunications Room Master Plan
- Comprehensive Technology Plan Roadmap

December 1, 2022

*Prepared for Anytown Central School District,
Anytown, NY*

Presented by Archi-Technology LLC

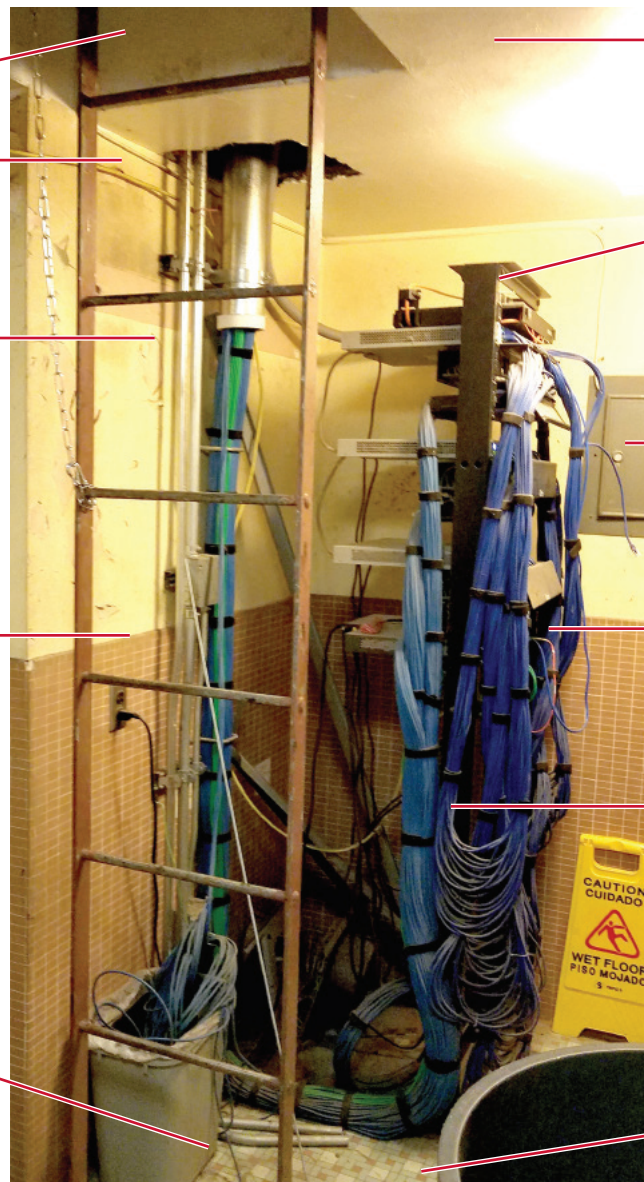
[2] Overhead utility pipes leave racks susceptible to damage from leaks/bursts.

[8] Lack of grounding infrastructure increases risk of electrical shortage and equipment damage.

[4] Unsecured, shared space creates a life safety and security risk as well as causing possible accidental damage.

[7] Lack of Uninterruptible Power Supply (UPS) or emergency power source creates life safety risks during power outages, and reduces equipment lifespan due to a lack of conditioned power.

[2] Dirty, dusty environment increases risk of operating issues with rack components and reduces equipment lifespan.

[13] Hard ceiling inhibits inspection and serviceability, and limits airflow while trapping heat.

[9] Overhead cable management is lacking putting cables at risk of damage.

[10] No cable management or correct termination at the rack can cause operational issues and makes troubleshooting difficult.

[1] Room size and inadequate rack clearances inhibit serviceability.

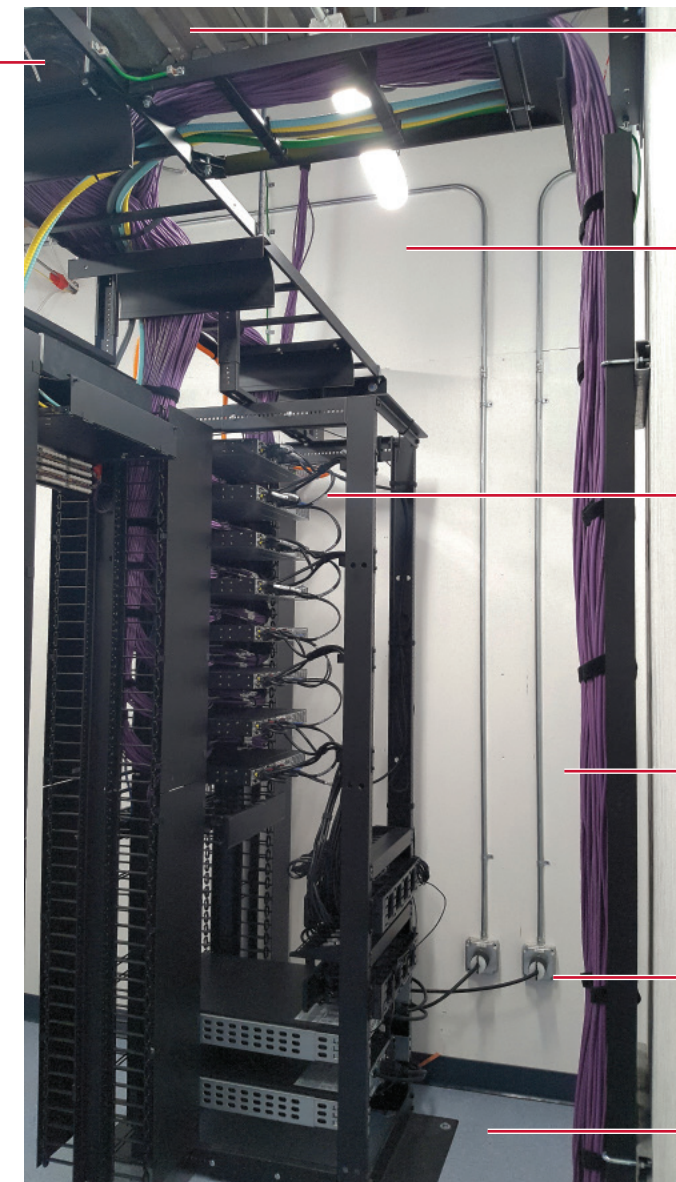
[8] Grounding infrastructure including a Telecommunications Grounding Busbar (TGB) is installed.

[7] UPS/EM Power. Uninterruptible Power Supply and/or Emergency Power source.

[13] Ceiling. Open to deck with 10' minimum height

[9] Overhead cable management and fire-resistant plywood wall are installed. Overhead ladder racks reduce strain on cabling and improve performance.

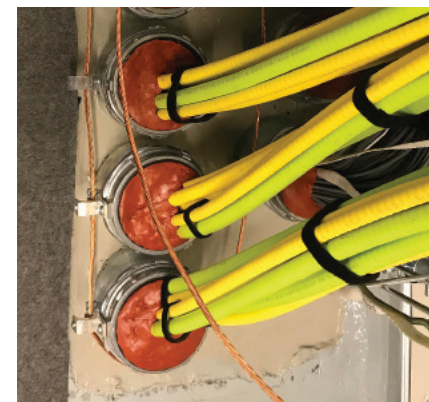
Conduit with proper fill ratio and properly installed firestop. Photo©BICSI. All rights acknowledged.

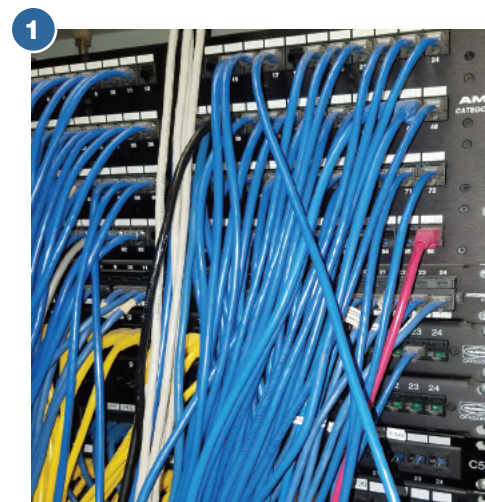
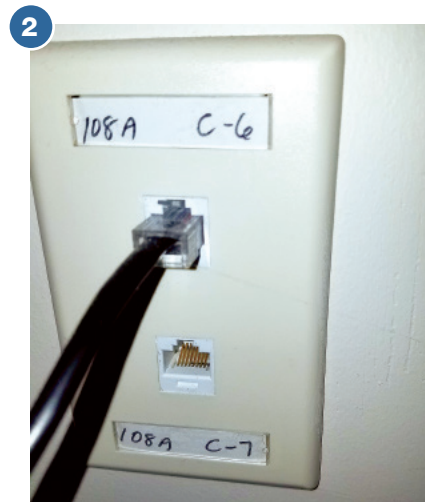
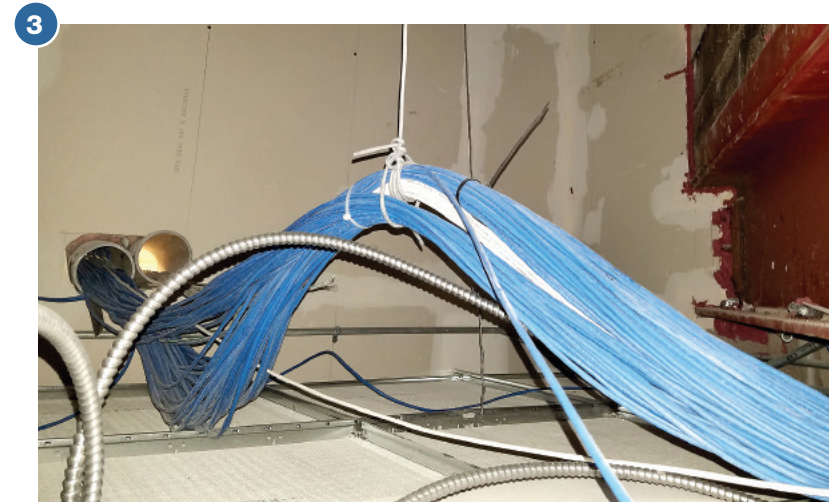
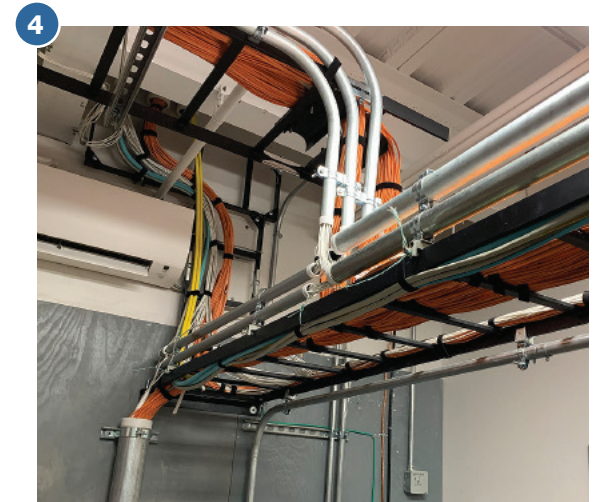
1. ES and MS non-compliant horizontal cable management.
2. Typical ES and MS cabling with non-compliant labeling.
3. Improperly supported horizontal cable in the High School.
4. Ladder racking correctly installed and deployed in the MTR - Server Room 154.

SYSTEM	SYSTEM GRADE	SYSTEM CATEGORY	CURRENT CONDITION	RECOMMENDED IMPROVEMENTS
Horizontal Cabling	3	Horizontal UTP Cabling	<ul style="list-style-type: none"> Category 6 (Cat6) cable was installed throughout the building as part of the 19/20 Capital Improvement Project. Analog video cameras are still wired with coax cable. There are large quantities of abandoned cabling throughout the building. 	<ol style="list-style-type: none"> 1. Replace the video surveillance system coax cable with Cat6 when the cameras are upgraded to IP-based versions. 2. Remove all abandoned cable and outdated legacy equipment. 3. Standardize all TR designations per the <i>TR Master Plan</i> included in this Report. 4. Implement a consistent district-wide cable labeling program from TRs through cable drops in classrooms and all other spaces that conforms with industry standards. 5. Make new district Serving Zone drawings developed with this report available to pertinent staff and contractors.

4	Cable Counts	Generally, cable counts are adequate for current District needs.	
	2	Cable Labeling	The district lacks cable labeling conventions resulting in inconsistent and inadequate cable labels throughout the district.	
	0	Serving Zones	Serving Zones for each floor are not documented.	
	4	Wireless Access Point (WAP) Cabling	(2) Cat6A cables are installed for each WAP.	
Backbone Cabling	4	Intra-building Fiber Optic Backbone (within a building)	50-micron Multi Mode (MM) and Single Mode (SM) fiber are installed throughout the building.	No recommendations at this time.
	N/A	Inter-building Fiber Optic Backbone (between buildings)	The district has a single Central School building with no inter-building connections.	
Communications Pathways	2	Cable Tray	Except for the Main Telecom Room (MTR), there is minimal use of cable tray throughout the District.	<ol style="list-style-type: none"> 1. Install new/add cable tray down all corridors and in other areas of the building. 2. Correctly install all existing and new cable into the tray.

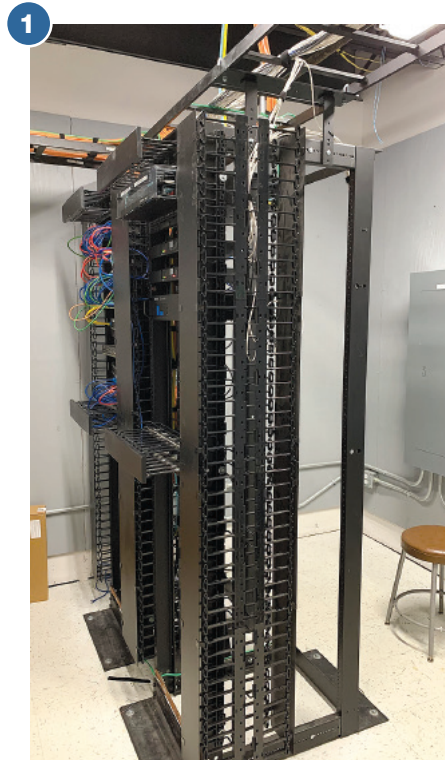
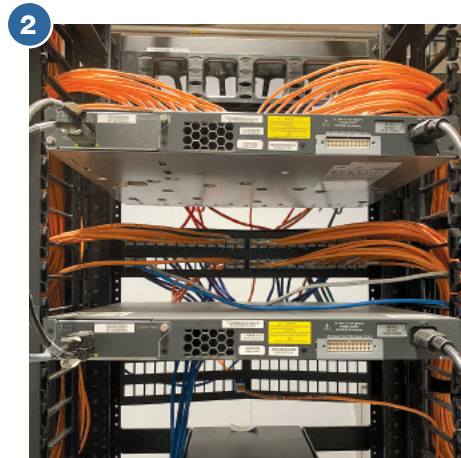
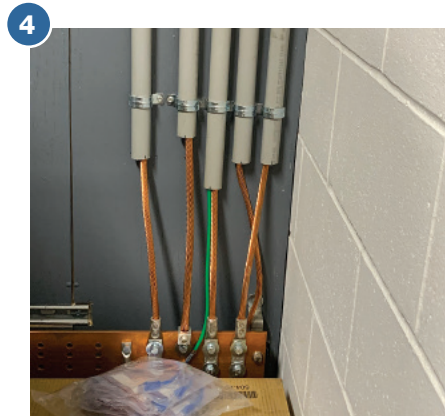
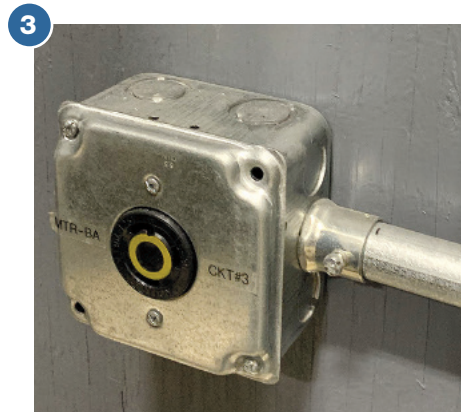
CURRENT CONDITION
The space is in **good** condition and requires moderate upgrades to meet industry standards.

Photos, clockwise from top left:
 1. The dedicated secure space includes (3) newer equipment racks.
 2. The racks include properly installed cable lengths and management.
 3. A properly labeled electrical outlet from the building's emergency generator.
 4. A properly installed grounding bar with all components correctly connected.

RECOMMENDATION
Upgrade the current space.

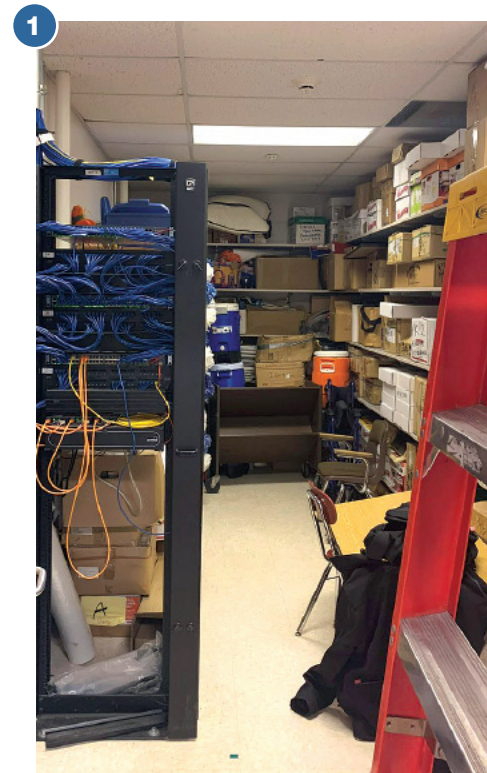
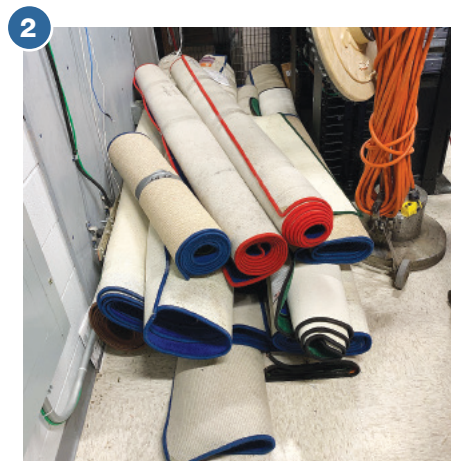
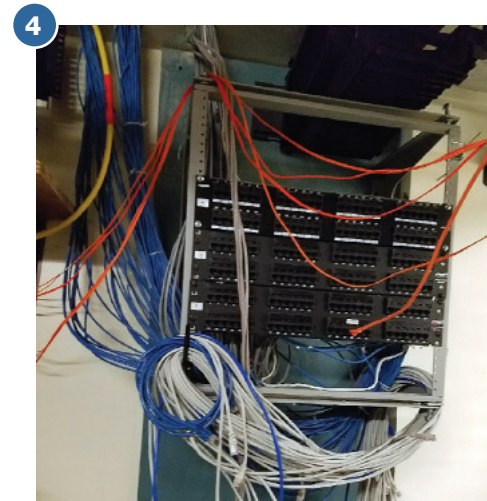
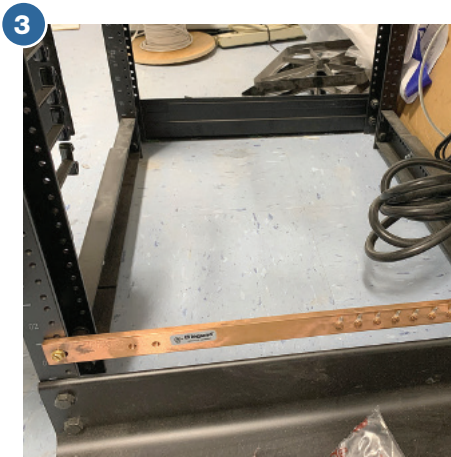
The space is in **poor** condition and requires **significant** upgrades to meet industry standards.

Photos, clockwise from top left:

1. Unsecured space shared with office supply storage.
2. Rugs are stored in close proximity to IT equipment racks.
3. A grounding bar is installed in the rack but no equipment is connected to it.
4. Abandoned legacy cable installed in the space.

RECOMMENDATION
Dedicate and upgrade the current space.

1. Remove stored non-IT items. Dedicate the space to IT equipment and install card access for IT staff only.
2. Move IT equipment from ITR-3, Basement (B 028A) to this space. Recable the equipment in the racks.
3. Installed video surveillance of door exterior.
4. Install AC system, temperature monitoring, a UPS unit, cable management systems, and firestop in conduits.
5. Attach IT equipment to existing rack grounding bar.
6. Install plywood on one wall and remove the drop ceiling.

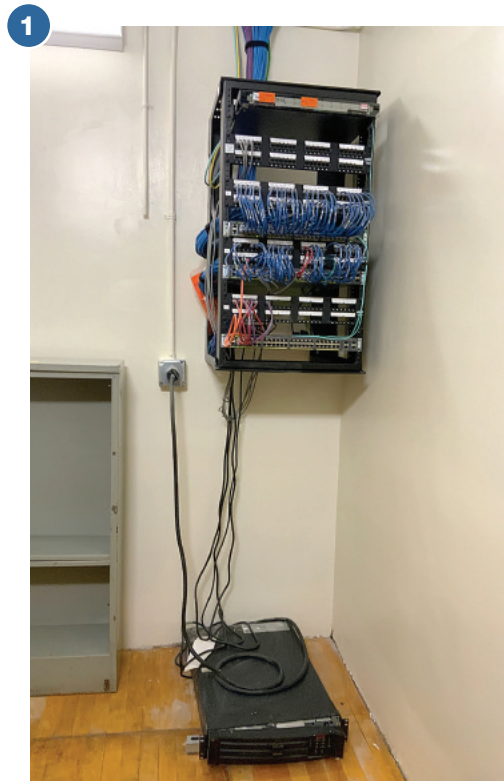
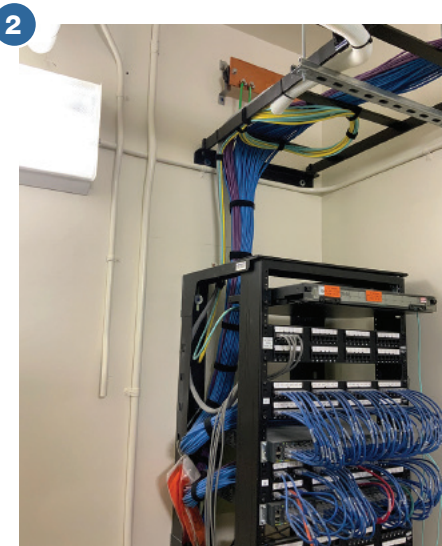
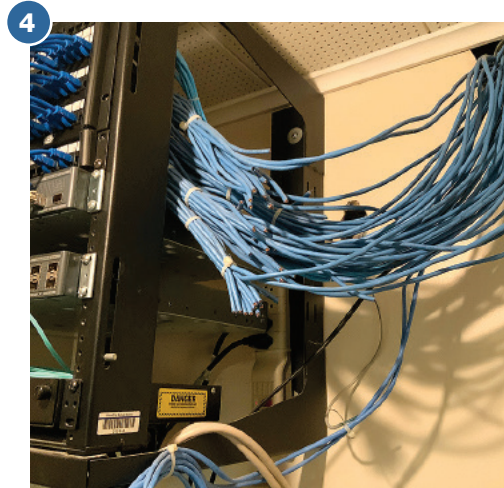
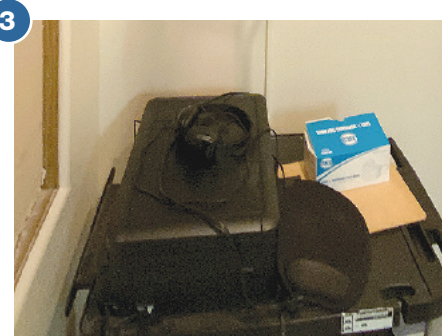
The space is in **good** condition and requires **nominal** upgrades to meet industry standards.

Photos, clockwise from top left:
 1. A single wall-mount cabinet is installed in the secured dedicated space.
 2. Proper vertical and overhead cable management, and grounding systems are used in the space.
 3. A few non-IT items are stored in the space.
 4. Horizontal cable supports are lacking at the cabinet and abandoned cables have not been removed from the rack.

11. Room Construction	2	<ul style="list-style-type: none"> • The walls extend to the deck but plywood is not installed on any wall. • Cables enter the space in non-compliant pathways. 	<ol style="list-style-type: none"> 1. Install plywood that is either fire retardant or intumescent painted on at least one wall. 2. Install properly sized conduit with proper firestop where it is lacking.

12. VCT Flooring	1	Wood flooring is installed.	Install anti-static VCT floor bonded to the grounding system with copper strips.
13. Ceiling	2	A drop ceiling is installed more than 10' Above Finished Floor.	Remove the drop ceiling.

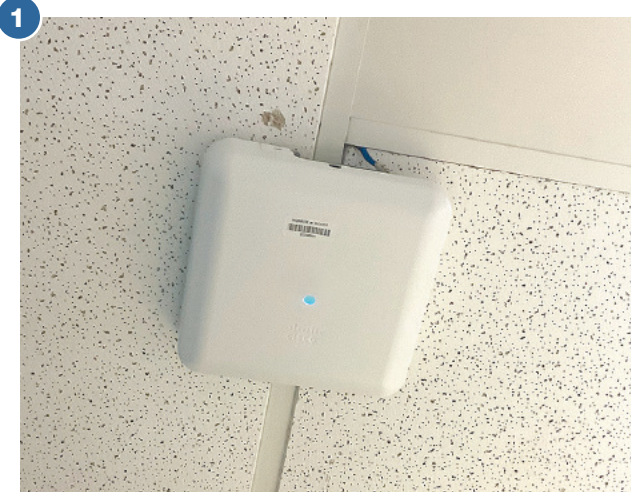
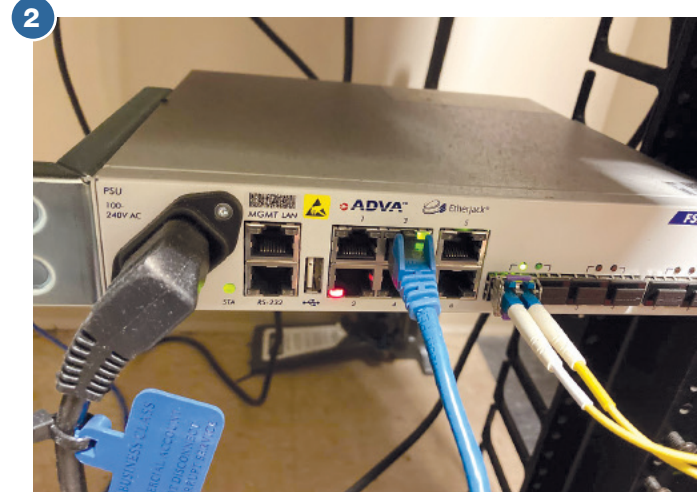
Photos below, left to right:

1. A ceiling-mounted WAP in an Elementary School classroom.
2. The Spectrum internet connection in the MTR.

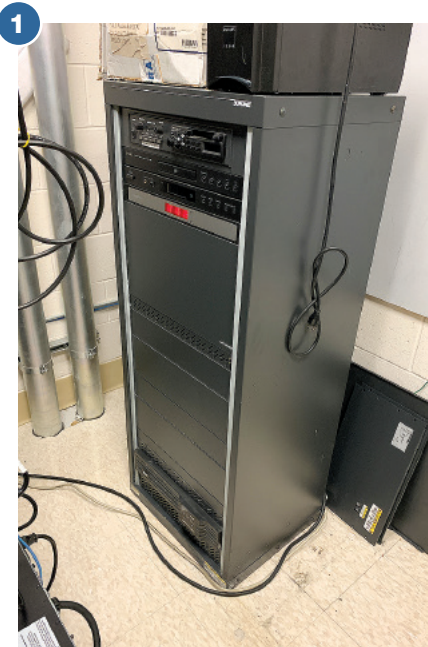
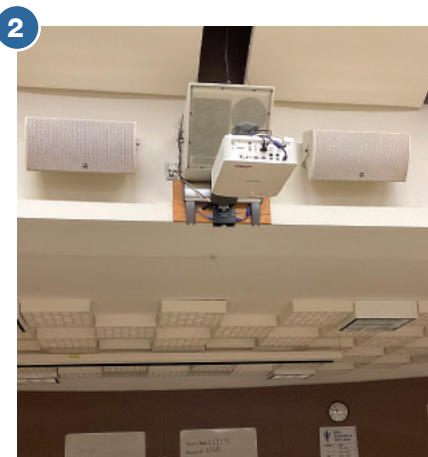
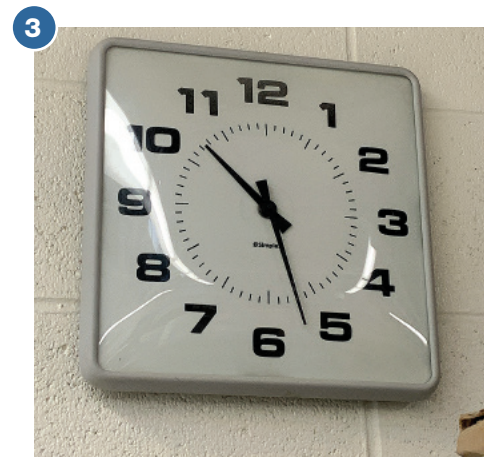
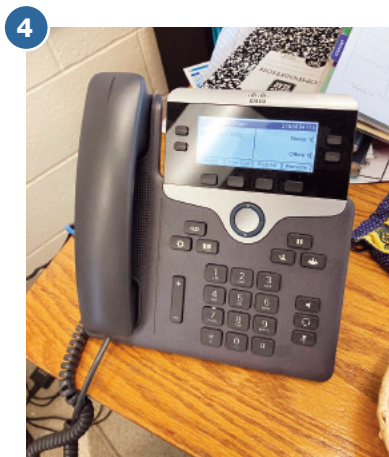
Photos below, left to right:

1. Outdated PA headend in the MTR.
2. A Large Group Instruction Audio-Enhancement system in the HS.
3. An analog clock in a High School corridor.
4. A Cisco VoIP handset on a teacher's desk.

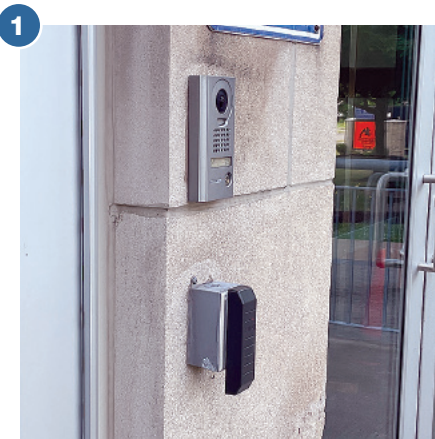
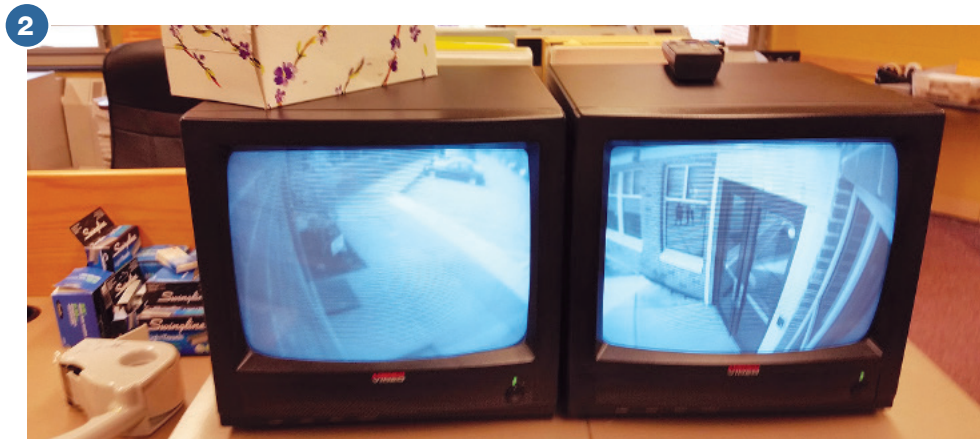
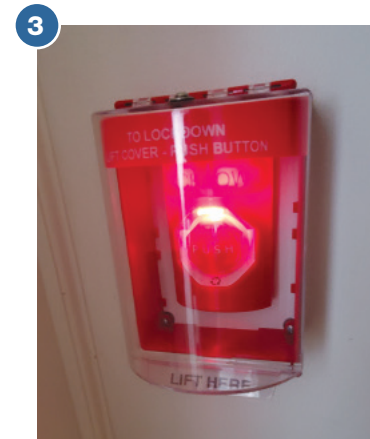
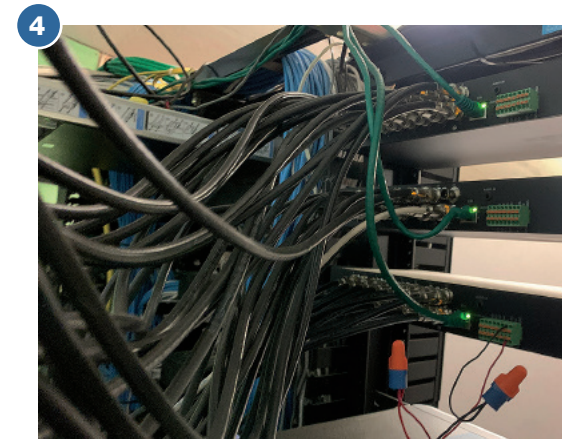
Photos below, left to right:

1. A typical card reader and video intercom installed at an exterior door.
2. Video Surveillance monitors are located in the District Office.
3. A typical Lockdown Initiation button in the HS Main Office.
4. Analog video surveillance equipment in the MTR.

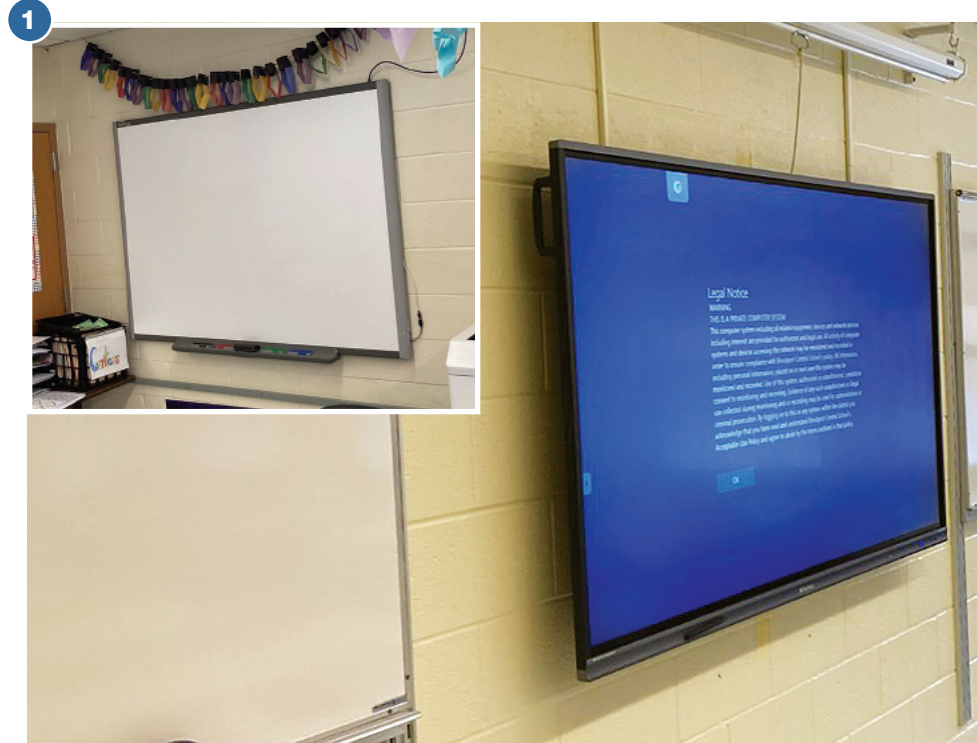
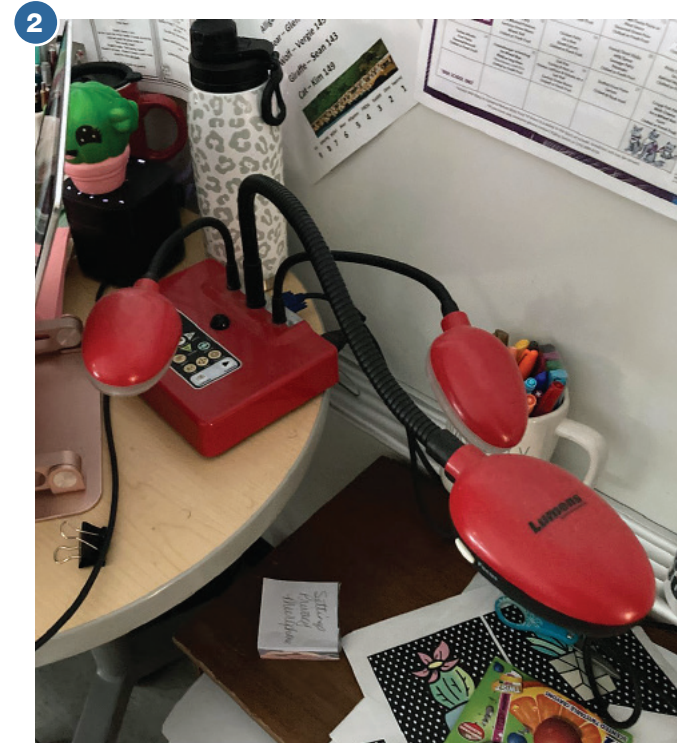
Photos, left to right:

- Outdated SMARTboards (inset) have largely been upgraded to Interactive Flat Panels (IFPs) in the past few years.
- A typical HD document camera in an ES classroom.

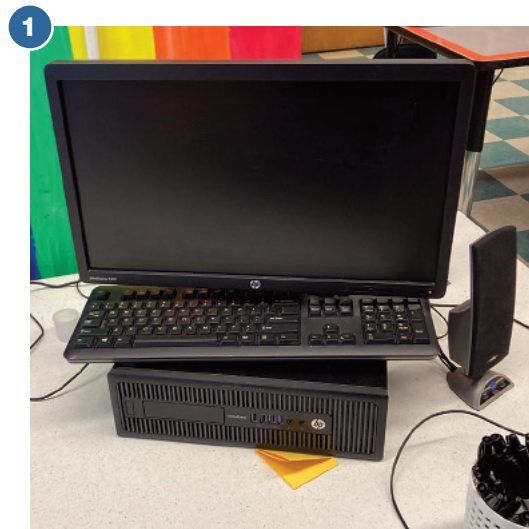
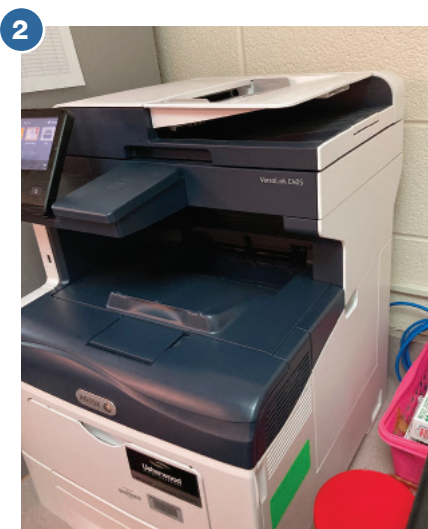
Photos left to right:

1. A teacher's classroom desktop in a classroom.
2. A typical classroom printer.
3. A newer iMac teacher desktop with a classroom laser printer.
